## Evaluation of Physical Infrastructure and Seismic Vulnerability in the Community of Joa, Jipijapa Canton

This work is a partial result from the research project entitled: “**Diagnóstico de infraestructura física para fomentar el desarrollo productivo del sitio Joa del cantón Jipijapa**”, financed by Universidad Estatal del Sur de Manabí.

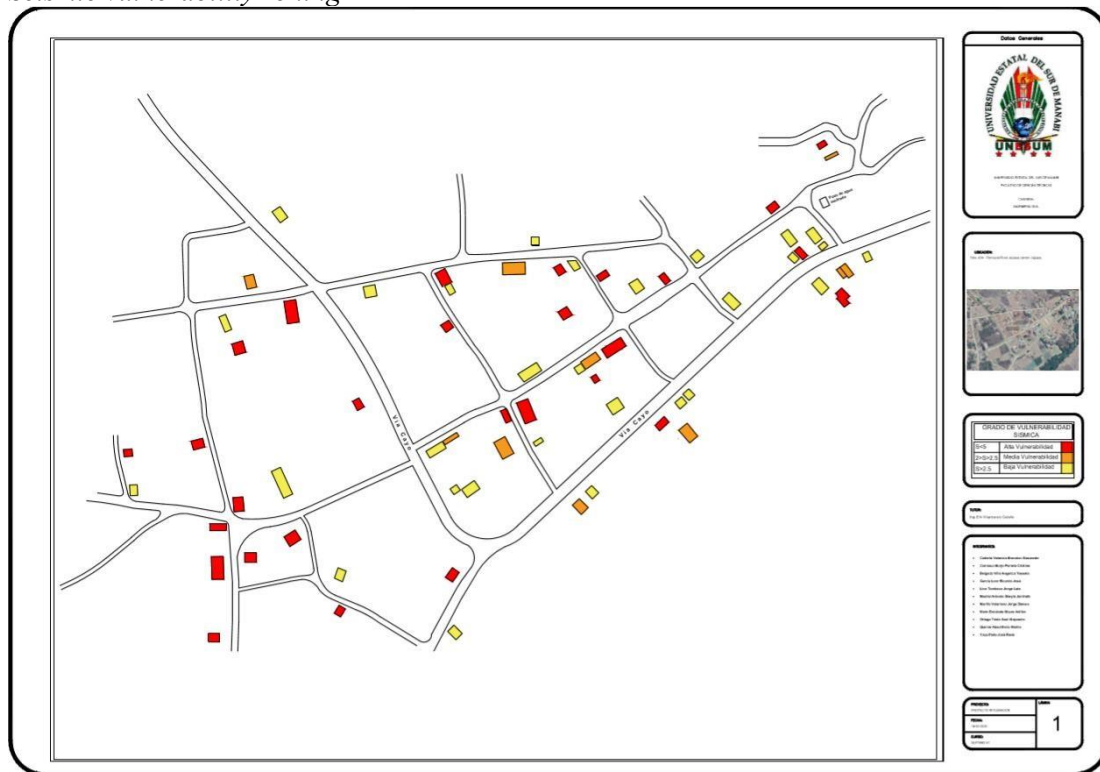
**Figure 1.**  
*Seismic vulnerability zoning*

Figure 1 shows a map of the Joa community in Jipijapa, Manabí, Ecuador, where the homes have been zoned according to their seismic vulnerability. Homes are represented by

colored dots: Red: Homes with high seismic vulnerability; Yellow: Homes with medium vulnerability; and Green: Homes with low seismic vulnerability.

A concentration of homes with high vulnerability (red dots) is observed in the central and southern part of the community. Homes with low vulnerability (green dots) are found mainly on the periphery and scattered in other areas. Homes with medium vulnerability (yellow dots) appear to be more evenly distributed throughout the community, although in smaller numbers.

Considering the previous analyzes, it is likely that the concentration of homes with high vulnerability in the center and south of Joa is due to the presence of older buildings, built with techniques and materials that are less resistant to earthquakes. The houses on the periphery, possibly of more recent construction and with better construction practices, could explain the greater presence of green dots in that area. The dispersed distribution of homes with medium vulnerability could indicate a combination of factors, such as the age of the buildings, the quality of the materials and the type of structural system used.

The map allows clearly identifying the areas of Joa with the highest concentration of vulnerable homes, which facilitates the prioritization of reinforcement or rehabilitation interventions. Information on the distribution of seismic vulnerability is essential for urban planning and the future development of the community, promoting the construction of new homes in lower risk areas and establishing stricter construction regulations. The map is a key tool for emergency planning and seismic risk management, allowing the identification of the areas where
